APPENDIX 10E: OTTER AND WATER VOLE SURVEY REPORT.

South Humber Bank Energy Centre

Appendix 10E: Otter and Water Vole Survey

Applicant: EP SHB Limited
Date: December 2018

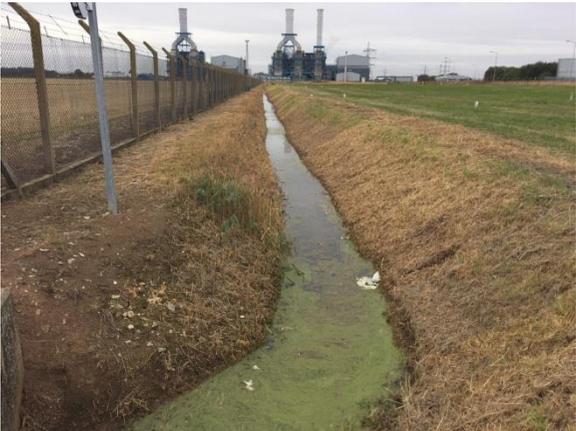
DITCH/ POND REFERENCE	DESCRIPTION	RELATIONSHIP TO THE SITE AND MAIN DEVELOPMENT AREA	WATER VOLE FIELD SIGNS	OTTER FIELD SIGNS	PHOTOGRAPH
1	A wet drain supporting a continuous linear stand of emergent and marginal common reed (<i>phragmites australis</i>) dominated swamp vegetation	Outside main development area. Runs along southern boundary of site.	✓	✓

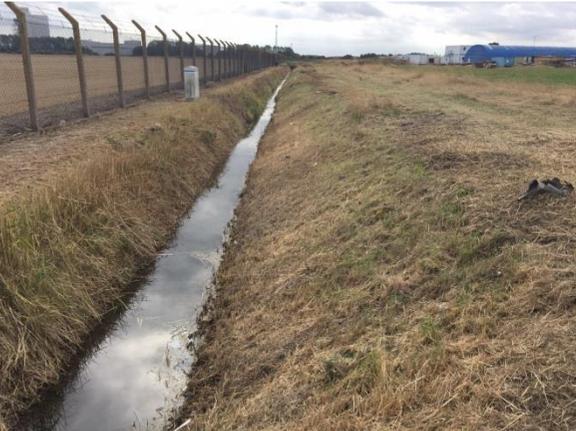
2	A wet drain supporting a continuous linear stand of emergent and marginal common reed dominated swamp vegetation	Outside main development area. Runs along southern boundary of site.	✓	x

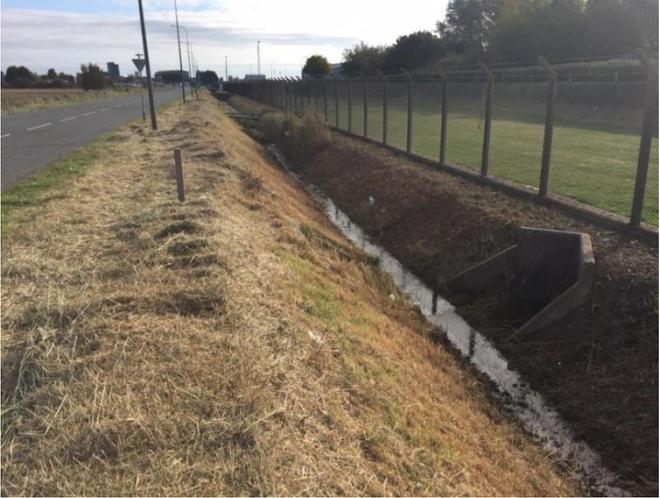
DITCH/ POND REFERENCE	DESCRIPTION	RELATIONSHIP TO THE SITE AND MAIN DEVELOPMENT AREA	WATER VOLE FIELD SIGNS	OTTER FIELD SIGNS	PHOTOGRAPH
3	<p>A wet drain with locally abundant emergent bulrush (<i>typha latifolia</i>). Semi-improved neutral grassland riparian habitat with frequent herb species eg. great willowherb (<i>epilobium hirsutum</i>) and water mint (<i>mentha aquatica</i>).</p> <p>The vegetation had been cut at the time of the survey.</p>	<p>Within main development area. Runs along northern boundary of site to south marsh road.</p>	✓	x

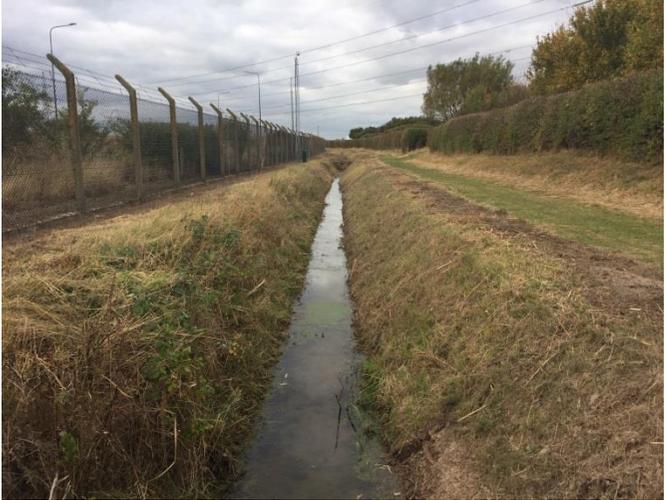
DITCH/ POND REFERENCE	DESCRIPTION	RELATIONSHIP TO THE SITE AND MAIN DEVELOPMENT AREA	WATER VOLE FIELD SIGNS	OTTER FIELD SIGNS	PHOTOGRAPH
4	<p>A wet drain with occasional emergent and marginal common reed semi-improved neutral grassland riparian habitat with occasional herb species.</p> <p>The vegetation had been cut at the time of the survey.</p>	<p>Outside main development area. Runs along eastern boundary of site.</p>	✓	✓

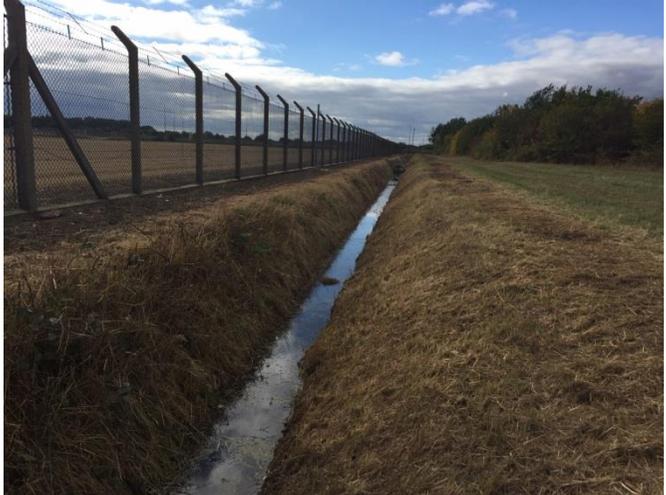
DITCH/ POND REFERENCE	DESCRIPTION	RELATIONSHIP TO THE SITE AND MAIN DEVELOPMENT AREA	WATER VOLE FIELD SIGNS	OTTER FIELD SIGNS	PHOTOGRAPH
5	A wet drain supporting a continuous linear stand of emergent and marginal common reed dominated swamp vegetation. The vegetation had been cut at the time of the survey.	Outside main development area. Runs along southern boundary of site.	✓	x

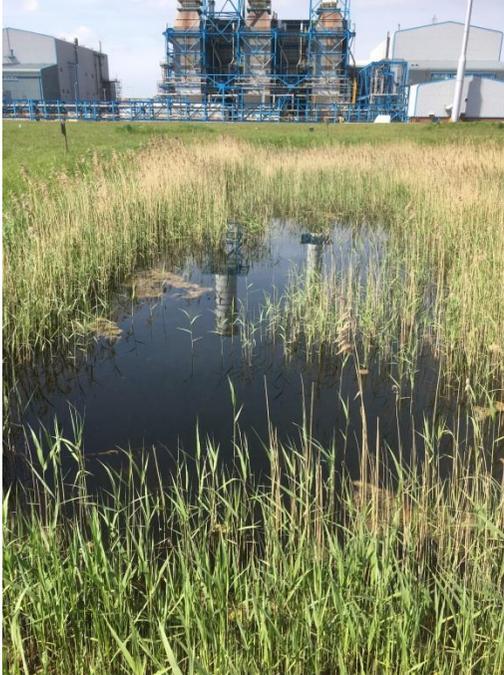
DITCH/ POND REFERENCE	DESCRIPTION	RELATIONSHIP TO THE SITE AND MAIN DEVELOPMENT AREA	WATER VOLE FIELD SIGNS	OTTER FIELD SIGNS	PHOTOGRAPH
Pond 1	Small pond with dense marginal fringe of common reed.	Within Main Development Area.	x	x

- 4.4 Mitigation for water vole will be required where there are any direct impacts on habitats, including mitigation for the draining and infilling of Ponds 1 and 2 as these provide supplementary habitat for water voles within the Site.

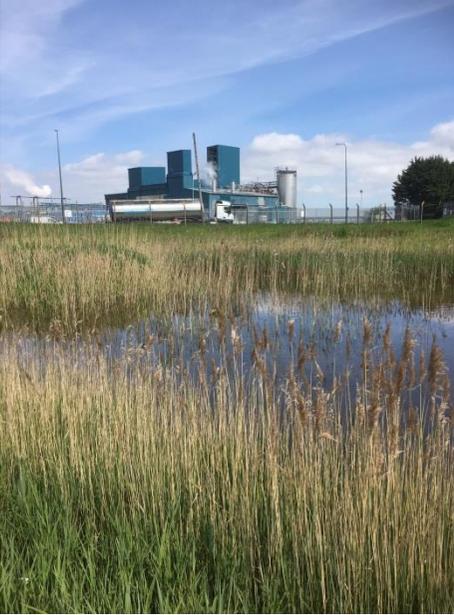
DITCH/ POND REFERENCE	DESCRIPTION	RELATIONSHIP TO THE SITE AND MAIN DEVELOPMENT AREA	WATER VOLE FIELD SIGNS	OTTER FIELD SIGNS	PHOTOGRAPH
Pond 2	Small pond with dense marginal fringe of common reed.	Within Main Development Area.	✓	x

- 4.2 There was also field evidence to suggest that water voles are likely to be using Pond 2 for foraging, although it is not considered that water voles would be resident on the pond given its small size. No burrows or droppings were found to indicate permanent presence. It is more likely that occasional foraging activity occurs by the population present on the surrounding ditches. Pond 1 is also in close proximity to a ditch in which water vole field signs were found, and therefore may also be used on occasion by foraging water vole. Given the small size of the ponds, only a small number of water voles would be expected to be present in this habitat, and possibly only single individuals given that they are territorial.
